# Process of rehabilitation of a XIX<sup>th</sup> century building in the city of Porto. Surveys, monitoring and intervention.

The present contribution details an intervention in a XIX<sup>th</sup> century building located in the Oporto Historical Centre buffer zone (UNESCO World Heritage since 1996). The building faced a series of problems related to structural instability and lack of maintenance for over half a century. The first phase incorporated surveys, monitoring and intervention on the roof.

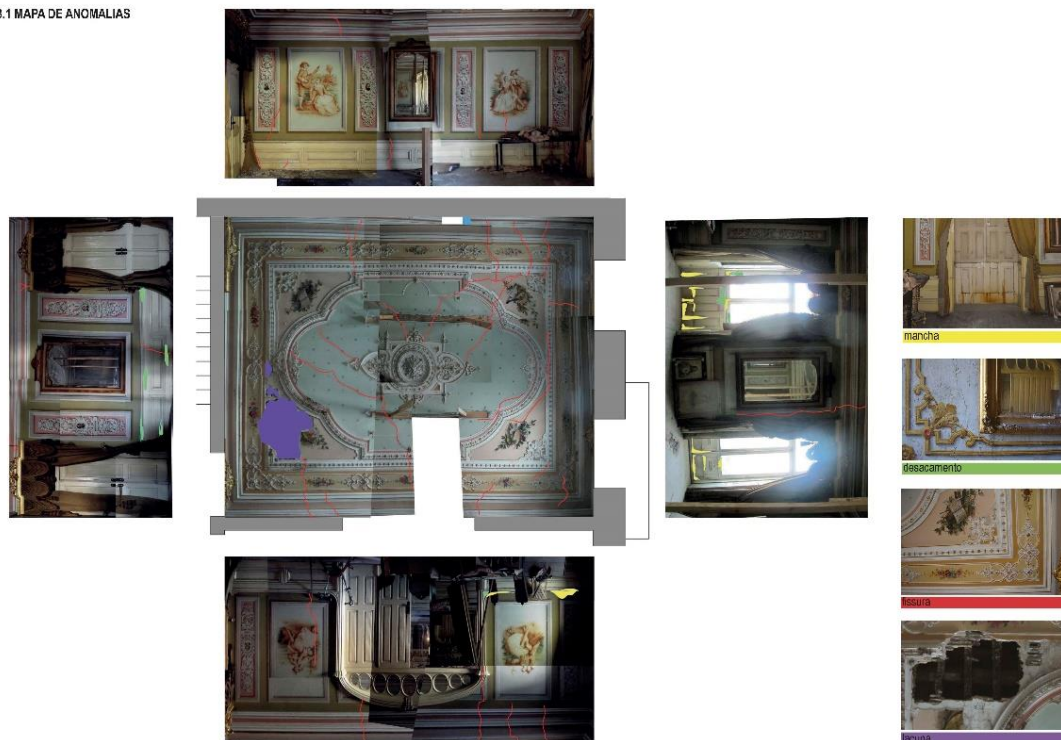
Anomalies were analysed using decay mapping in each room, resulting in a qualitative vision of the apparent damage to the masonry and partition walls, cladding, ceilings and floors, doors, woodcarving and windows. The most frequent damage consisted of cracks, the detachment of materials and coverings, stains and gaps. The cracks appeared in the ceilings and extended along the inner walls, being particularly evident in the skylight and the ceilings of the upper floor, due to structural problems, as well as the contraction and expansion of wooden elements exposed to variations in temperature and relative humidity. Occasionally the cracking caused fractures and gaps, mainly in the ceilings, as, for example, in the Music Room, a situation that was further aggravated by gravitational infiltration from the roof. The high relative humidity was also responsible for the stains in the coverings and wooden elements, highlighting the presence of saltpetre, mould and vertical drainage.

Figure 3. Decay mapping (Music room).

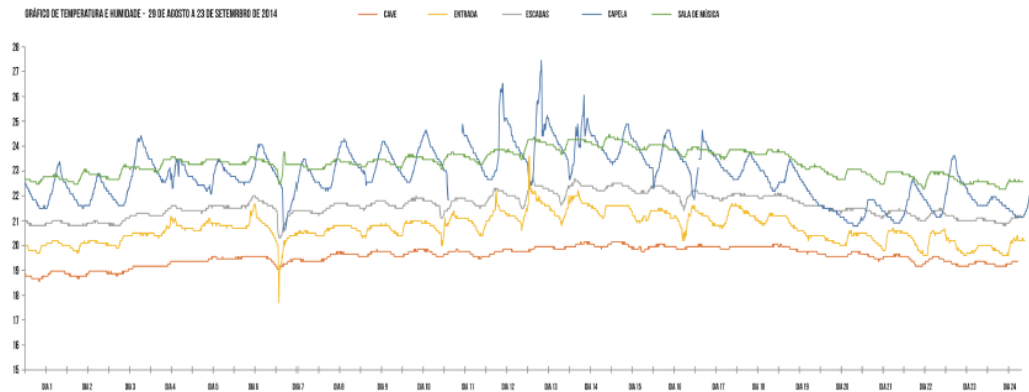
Figure 4. Temperature monitoring (from 29<sup>th</sup> august 2014 to 23<sup>rd</sup> september 2014)

The monitoring of the temperature and relative humidity, conducted at intervals of 15 minutes for a period of 25 days in the hot season (from 29 August to 23 September 2014), made it possible to understand the effects of the building's lack of use on the anomalies identified by the decay mapping (Fig. 4). The combination of a relative humidity of more than 65% and a temperature constantly above 20°C led to an increased risk of mould growth, speeding up the life cycle of wood-eating insects and encouraging the development of chemical reactions such as chromatic changes or the crystallisation of salts. The relative humidity conditions that were identified were further exacerbated by the gravitational humidity caused by leaks in the roof, which are expected to be solved with the present intervention.

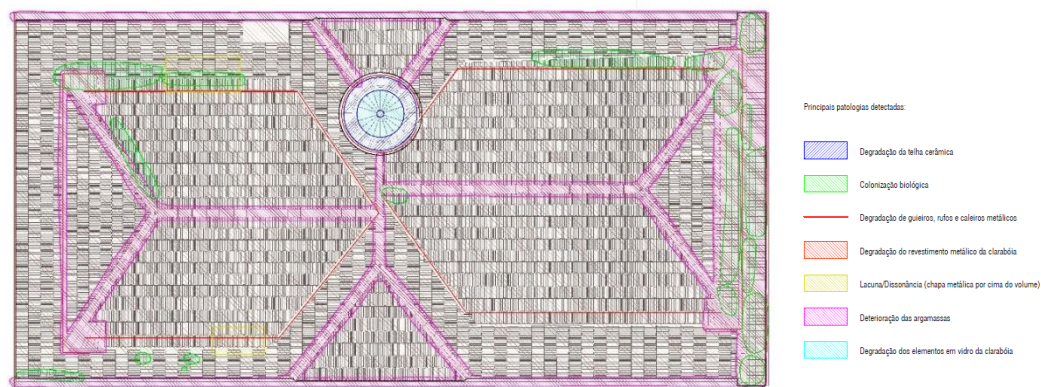
The main problems identified generally involved the deterioration of ceramic tiles, the deterioration of the timber structures (due to the presence of water, insects and fungi), the decay of the mortars, painted wooden elements and the metal features, among others problems such as (Fig. 5):

- Advanced decay of the tiles with a considerable number of them either broken or with low levels of waterproofing;
- Advanced deterioration of the eave tiles due to the presence of biological colonization and the decay of the setting mortars;
- Decay of the gable and crowning tiles alongside the rotting of the mortar fixing;
- Advanced degradation of the recessed floor metal sheeting and lack of slate tiles;
- Advanced decay of the skylight cladding sheet and its drip tray and of the upper metallic edge;
- Deterioration of the rainwater drainage system, including the metal guides, gutters, the back downpipe and the capitals;
- Decay of some timber features due to rot or insect and fungal attack (beams, rods, upper skylight structure support beam, roof lining and slats);

Figure 5. Decay mapping (roof)

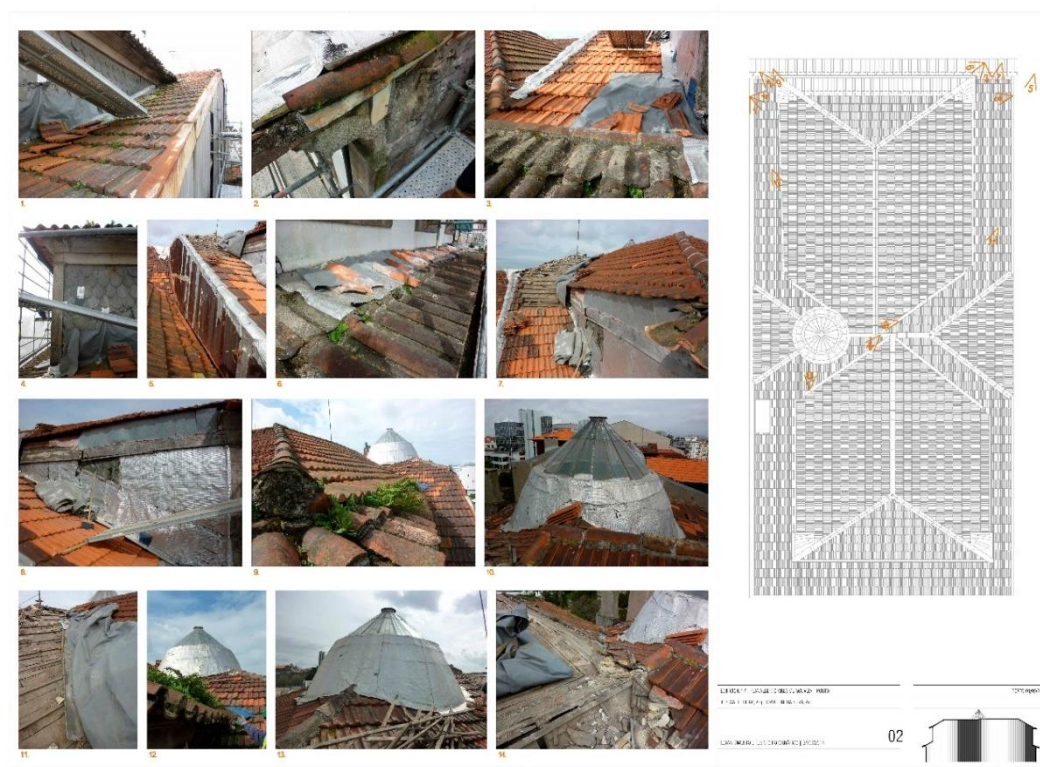
Figure 4. Photographic survey before the intervention

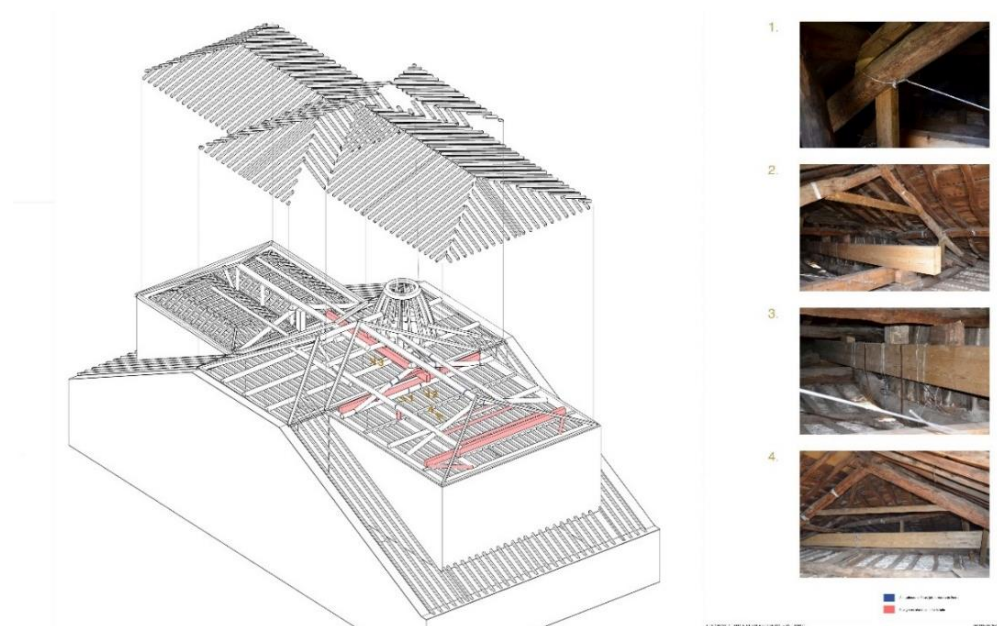
Figure 6. Axonometric representation with new structural elements in red

The intervention scope foresaw only minimal structural reinforcement (ISCARSAH, 2003), preserving all the timber structures still in good condition (structural features, beams and rods, liner) involving surface cleaning and curative and preventive treatment against the action of wood-destroying agents (xylophages), except for the slats and some of the lining that could not be preserved. Where necessary, the rods, beams and wood trusses were reinforced with prosthetic pine wood treated and bonded with metal brackets or clamps. Moreover, the skylight support beam structure was enhanced by a new beam in treated pine, which was embraced with the existing through metallic reinforces; the new beam was posed in a granite interior wall in one extremity and in a new beam in treated pine in the other extremity. Besides, another reinforcing beam was introduced near the façade to improve the connection between the façade wall and the side walls (Fig. 6).
